# Upland, CA

## Sidewalk and Curb Ramp Management Report

June 2024

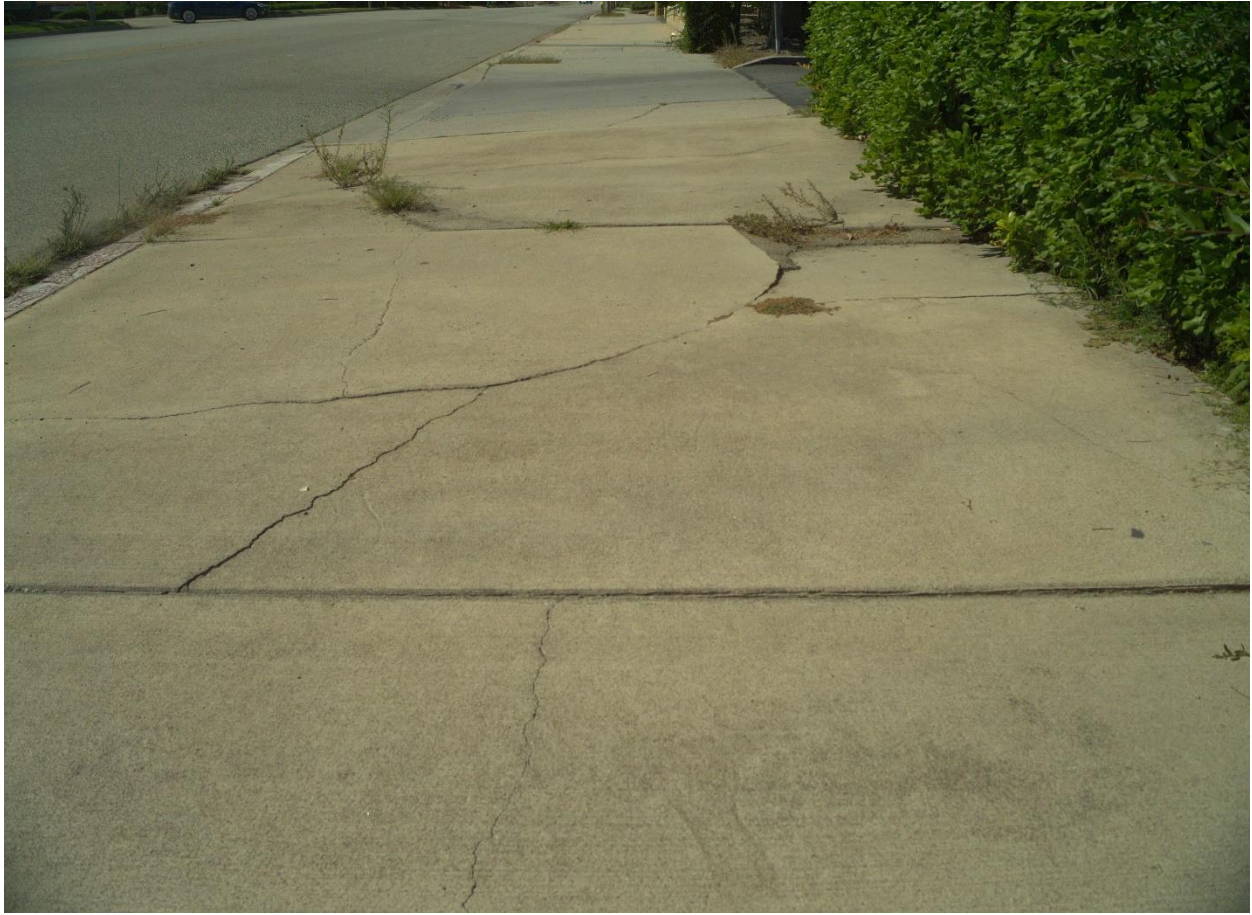
### Very Poor (0-25)

**Arrow Route (SWCI = 6 SWID = 103351)** – Several severe and moderate horizontal separations are present. This portion of sidewalk is flagged as an immediate priority should receive a complete remove and replacement. Areas where vegetation is growing within the cracks indicate that water is seeping into distressed areas and contributing to increased deterioration. Only 2% of the Upland network presents similar conditions.

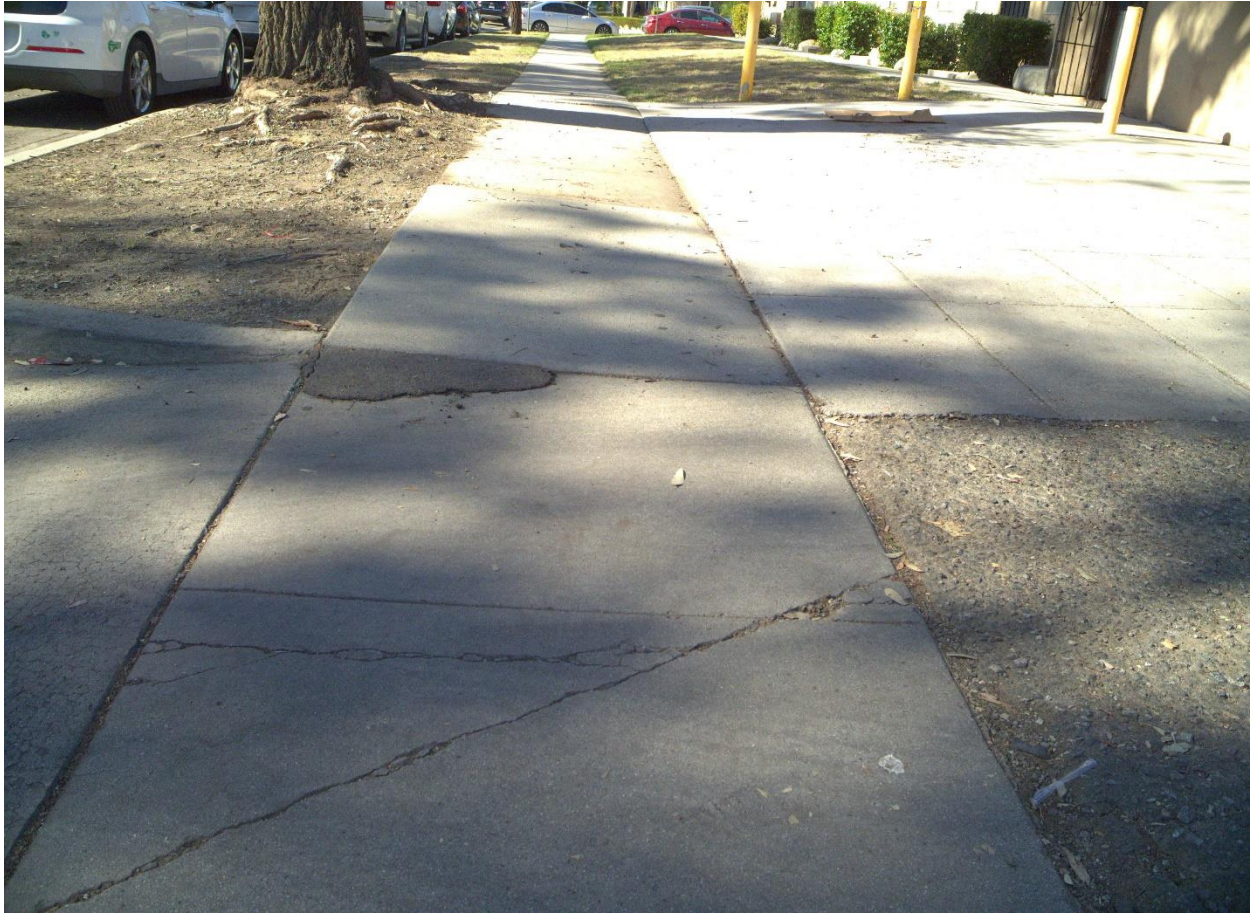
### Poor (25-50)

**Randy Street (SWCI = 37 SWID = 104448)** – This segment displays significant cracking. This image shows only the most distressed portion of the sidewalk. The distresses are not present along the entire length of the segment, so only a partial remove and replace with partial base replacement is suggested. Portions of this sidewalk have deteriorated to the point where it is now deterring ADA travel, notably the vertical displacement present in the above photo. The analysis has prioritized this particular segment as a “High Priority Rehab”. Segments displaying similar characteristics represent approximately 37% of the Upland sidewalk network.

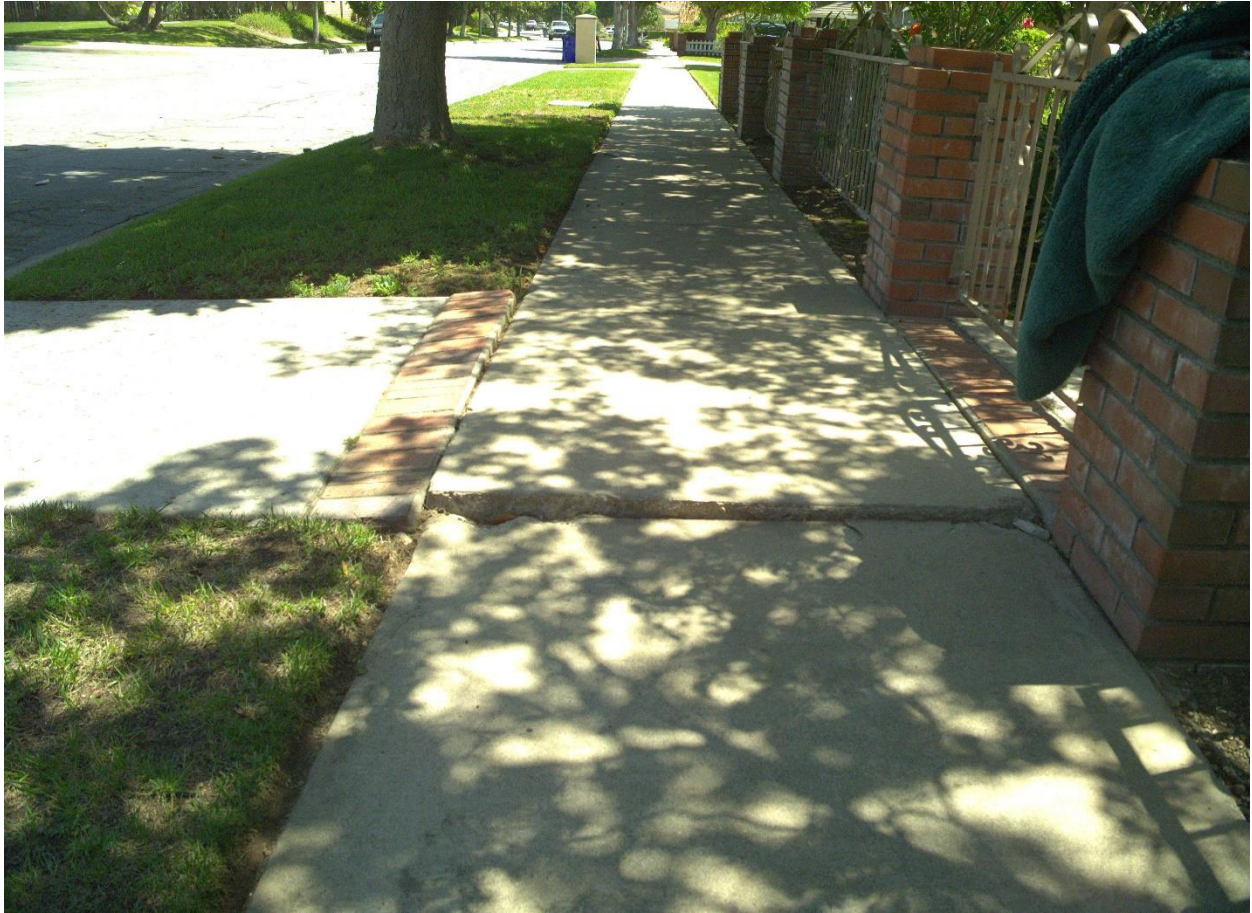
### Fair (50-75)

**Buffington Street (SWID-102687 SWCI= 68)** - This segment of sidewalk is in mostly serviceable condition with a few exceptions. There is a small amount of cracking between several panels but it is mostly low in severity. The largest concern is the severe vertical displacement shown in the image above. This is considered a severe tripping hazard and contributes very strongly towards the overall distress deducts calculated for this section of sidewalk. Approximately 47% of upland sidewalks fall into the Fair category.

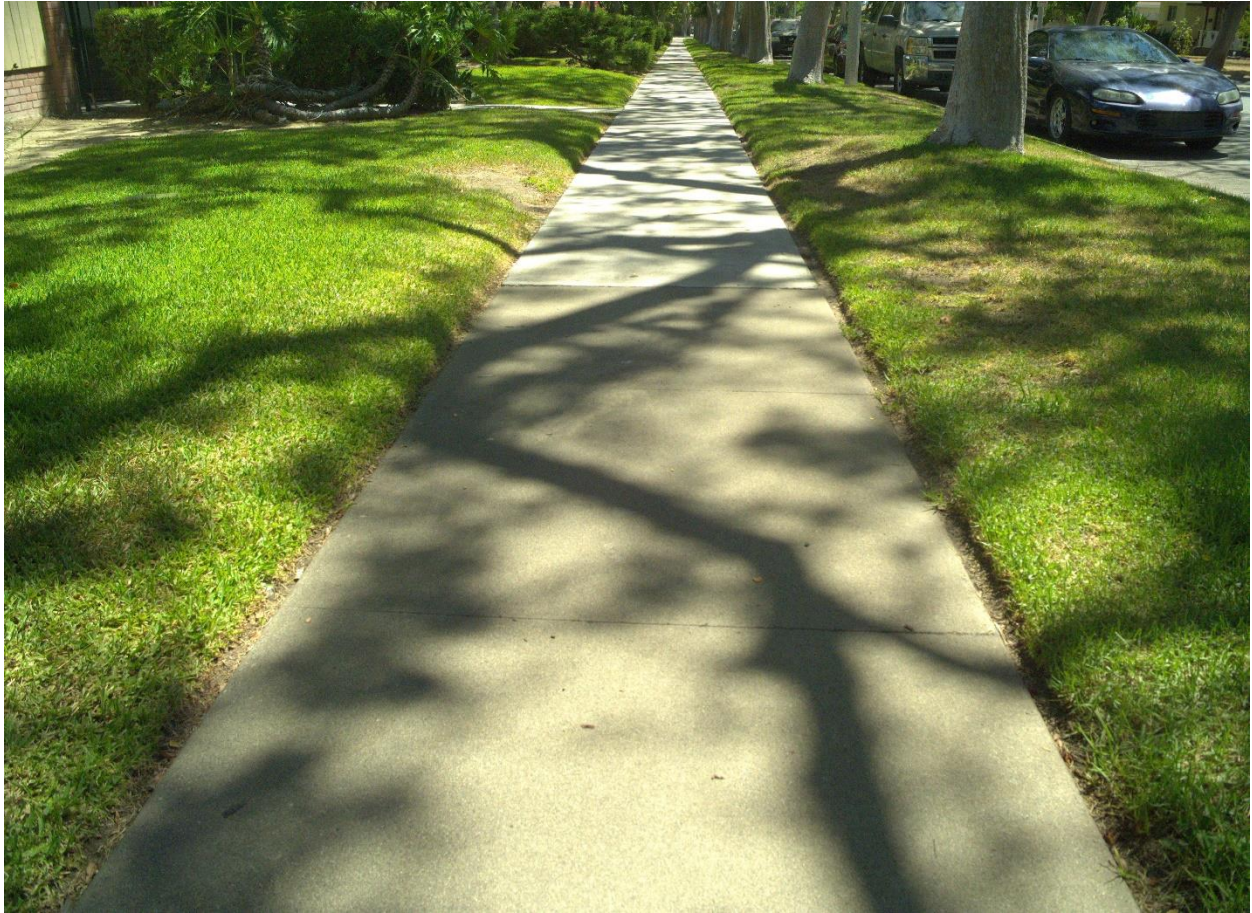
**Good (75-100)**

**Palm Avenue (SWID-105918 SWCI = 96)** - This segment of sidewalk is rated as “good” and displays no significant distresses. The analysis has determined this segment to be a low priority rehab. Around 14% of the Upland sidewalk network is in this condition category.

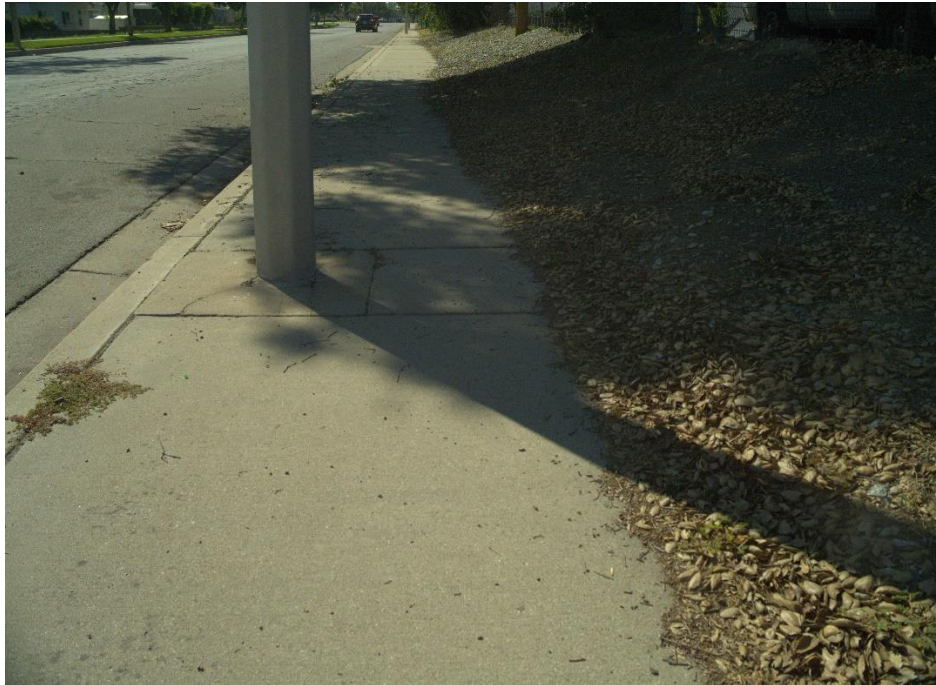
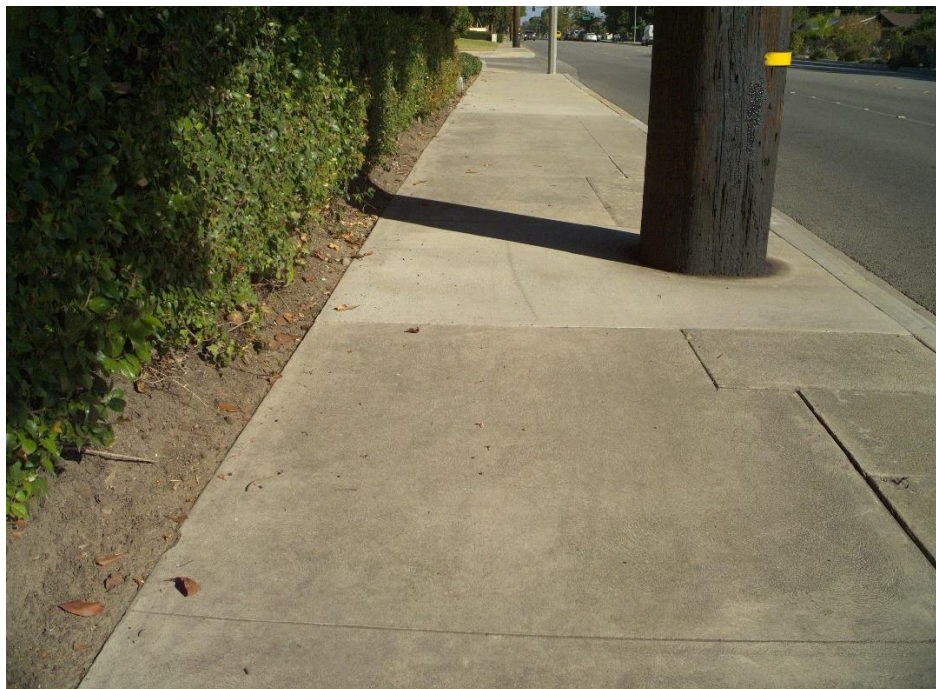
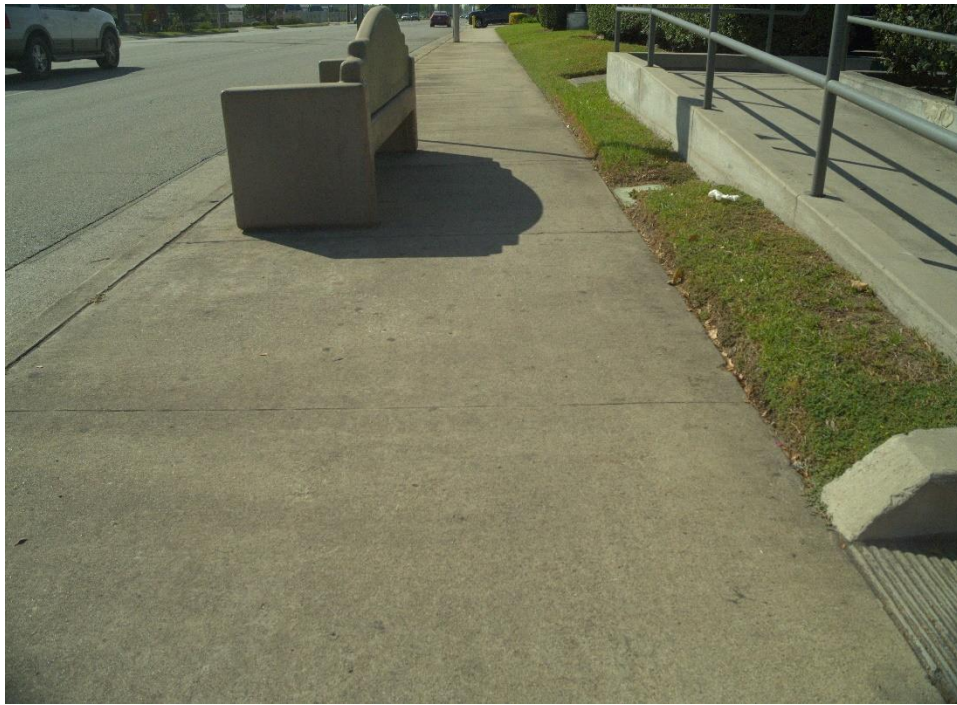
**Example Obstructions:**

In these examples, the power poles and street furniture restrict the width of the sidewalks. This negatively affects the traversability of the sidewalk by wheelchairs and other similar assisting devices. These obstructions should be removed or additional infrastructure should be built to allow the public to traverse the sidewalks with ease.

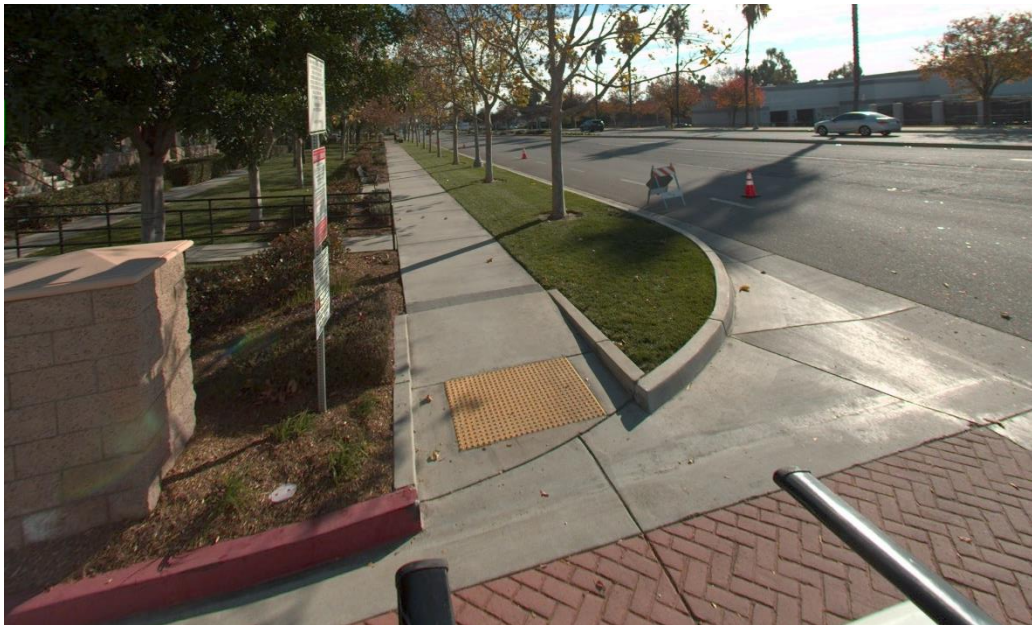
**Figure 11 - ADA Conformity Level 1 Ramp**

**ADA Conformity Level 1** are ramps (**Figure 11**) that have minimal (if any) ADA issues – they have a protective back curb (if necessary for the design style), the slopes appear to be within a reasonable range, and for applicable design styles, the ramp has a landing. The ramp will also usually have truncated domes.

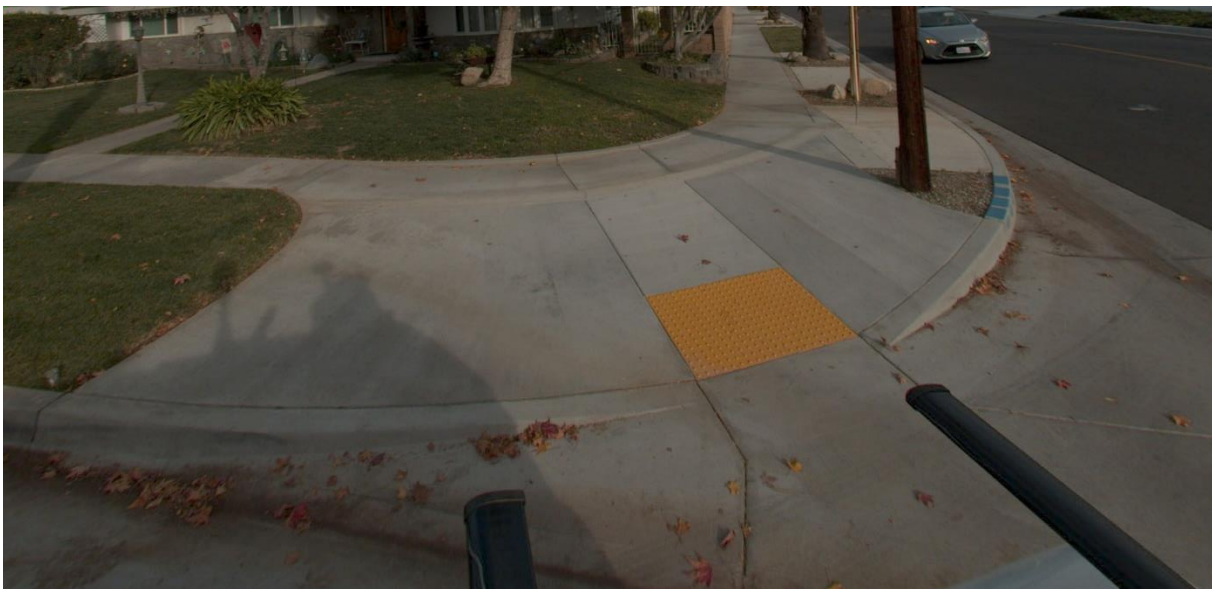
**Figure 12 - ADA Conformity Level 2 Ramp**

**ADA Conformity Level 2 ramps (Figure 12)** have slightly more ADA issues than ADA Conformity Level 1, i.e. the ramp may be missing a back curb, but is otherwise fine, in terms of slope, landing design, and presence of truncated domes. This type represents the most common ramp type in the City.

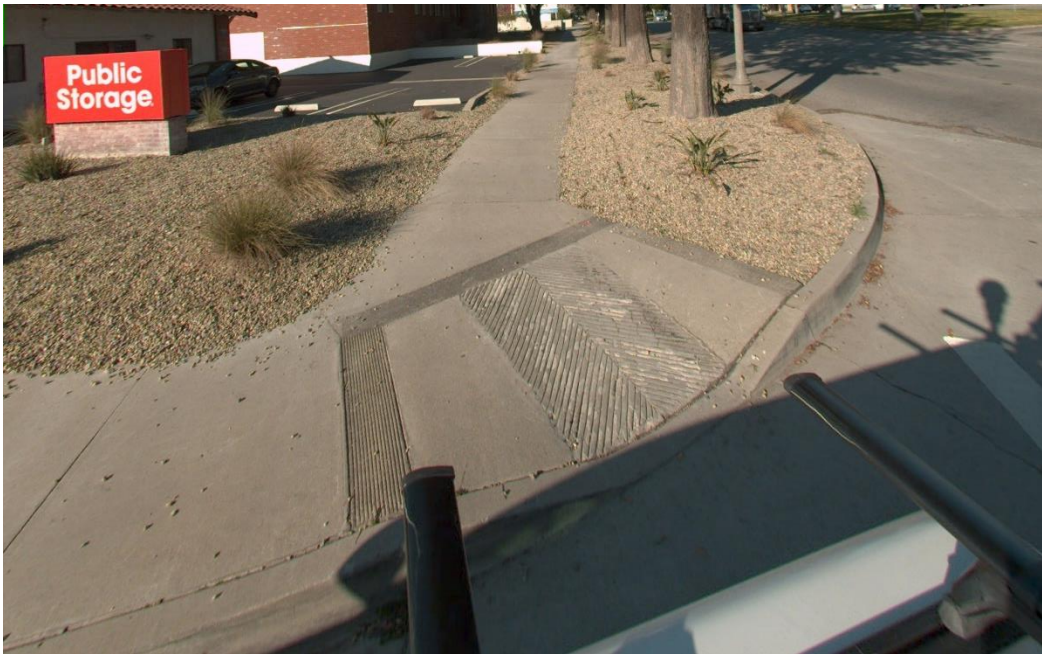
**Figure 13 - ADA Conformity Level 3 Ramp**

**ADA Conformity Level 3 ramps (Figure 13)** have two or more issues. For example, they may be missing a back curb and a truncated dome plate or have some sort of non-compliant visual impairment facility instead.

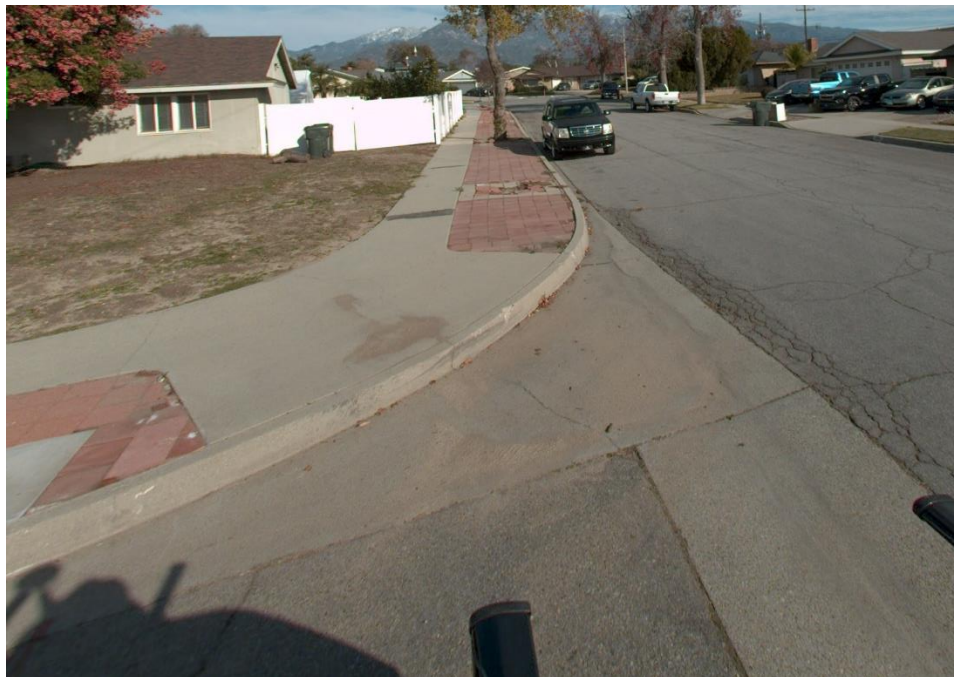
**Figure 16 - Ramp Required Point**

**Ramp Required points (Figure 16)** are locations where ramps are not installed, but they should be.
