STANDARDS FOR REHABILITATION & GUIDELINES
FOR REHABILITATING HISTORIC BUILDINGS

GUIDELINES FOR REHABILITATING HISTORIC BUILDINGS

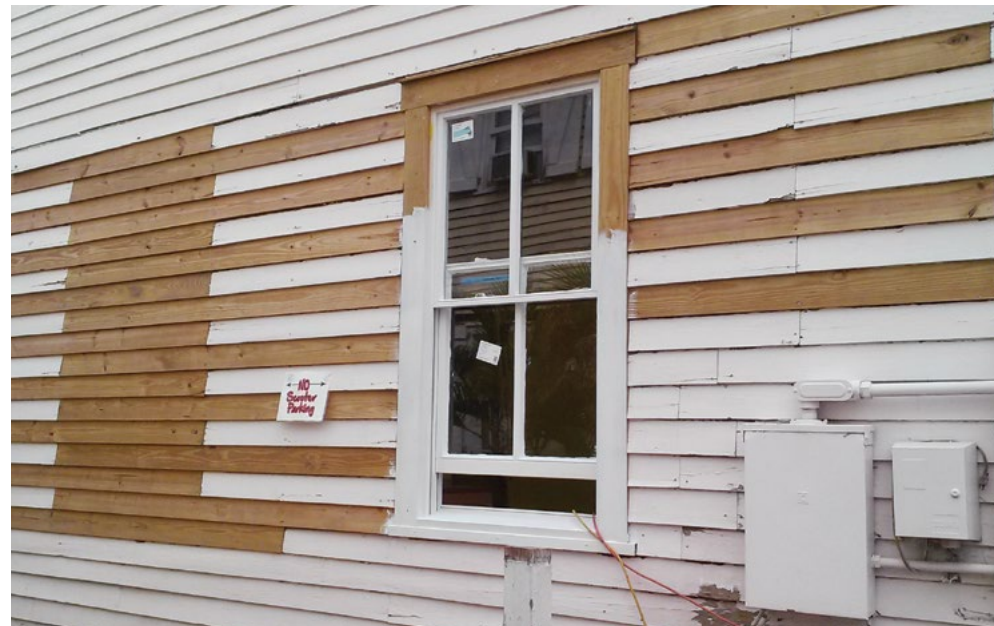
[8] Rotted clapboards have been replaced selectively with new wood siding to match the originals.

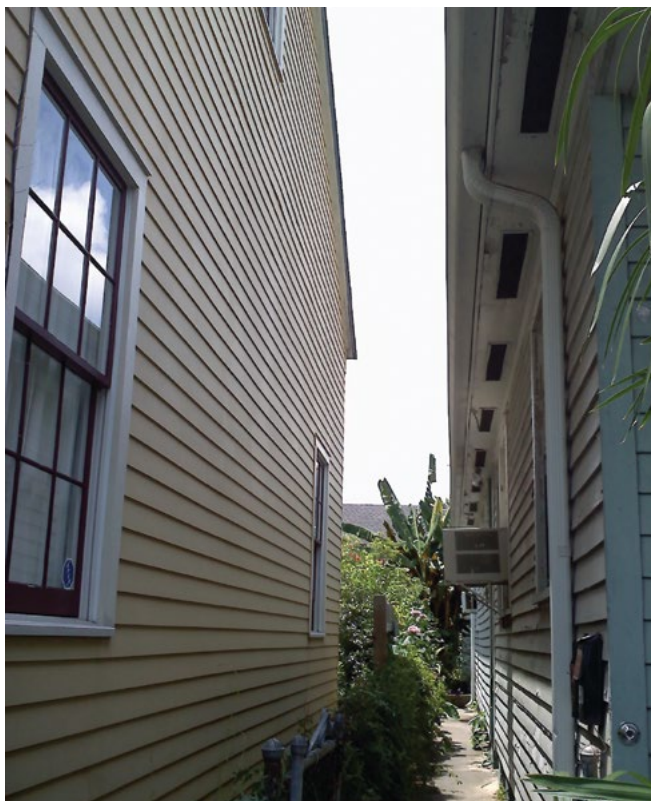
[9] Smooth-surfaced cementitious siding (left) may be used to replace deteriorated wood siding only on secondary elevations that have minimal visibility.

| RECOMMENDED | NOT RECOMMENDED |
|---|---|
| <p>Replacing a deteriorated wood feature or wood siding on a <i>primary or other highly-visible</i> elevation with a new matching wood feature.</p> | <p>Replacing a deteriorated wood feature or wood siding on a <i>primary or other highly-visible elevation</i> with a composite substitute material.</p> |

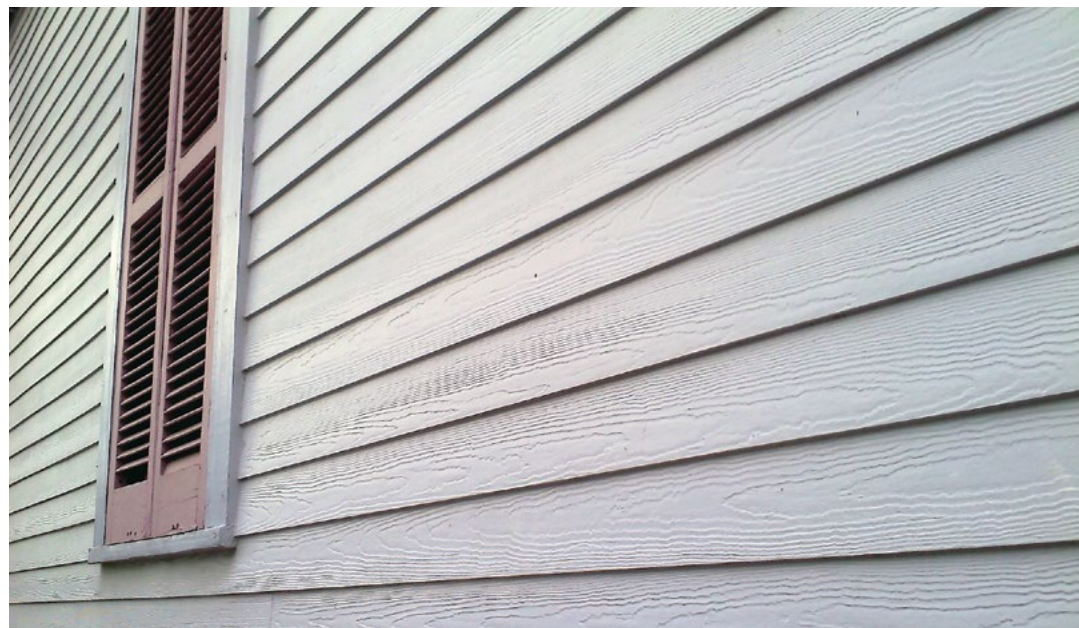
[10] **Not Recommended:** Cementitious siding with a raised wood-grain texture is not an appropriate material to replace historic wood siding, which has a smooth surface when painted.
