WINDOWS

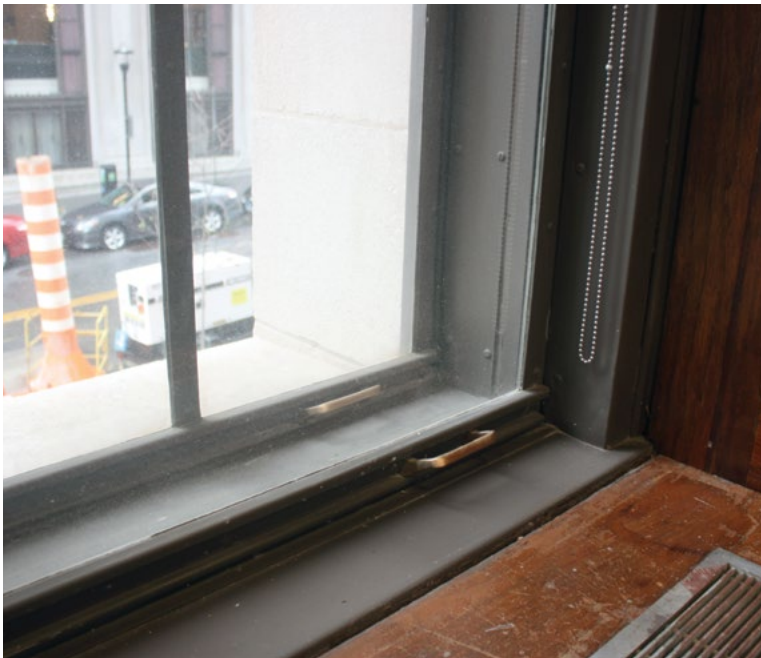
[18] The historic metal storm windows in this 1920s office building were retained and repaired during the rehabilitation project.

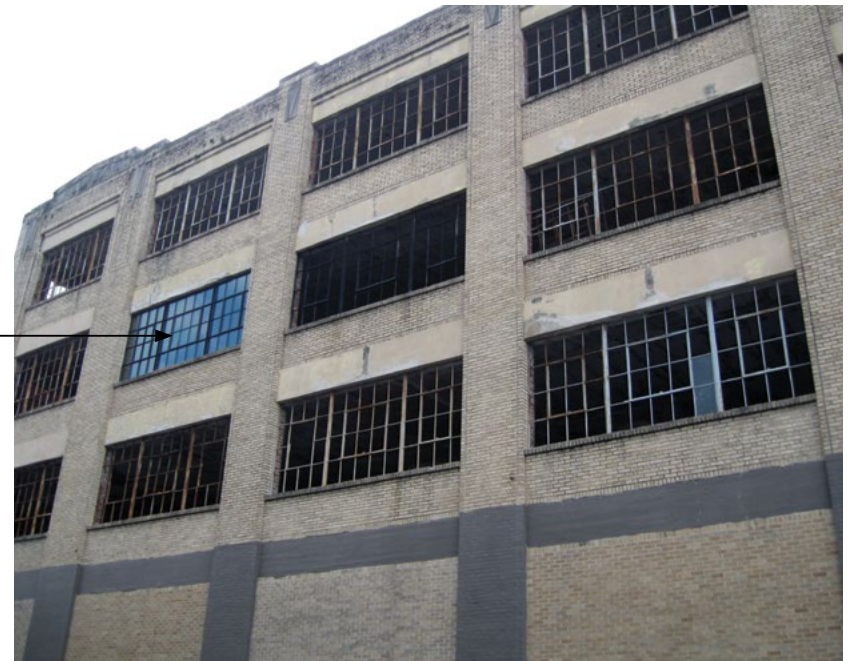
[19] Installing a mockup of a proposed replacement window can be helpful to evaluate how well the new windows will match the historic windows that are missing or too deteriorated to repair.

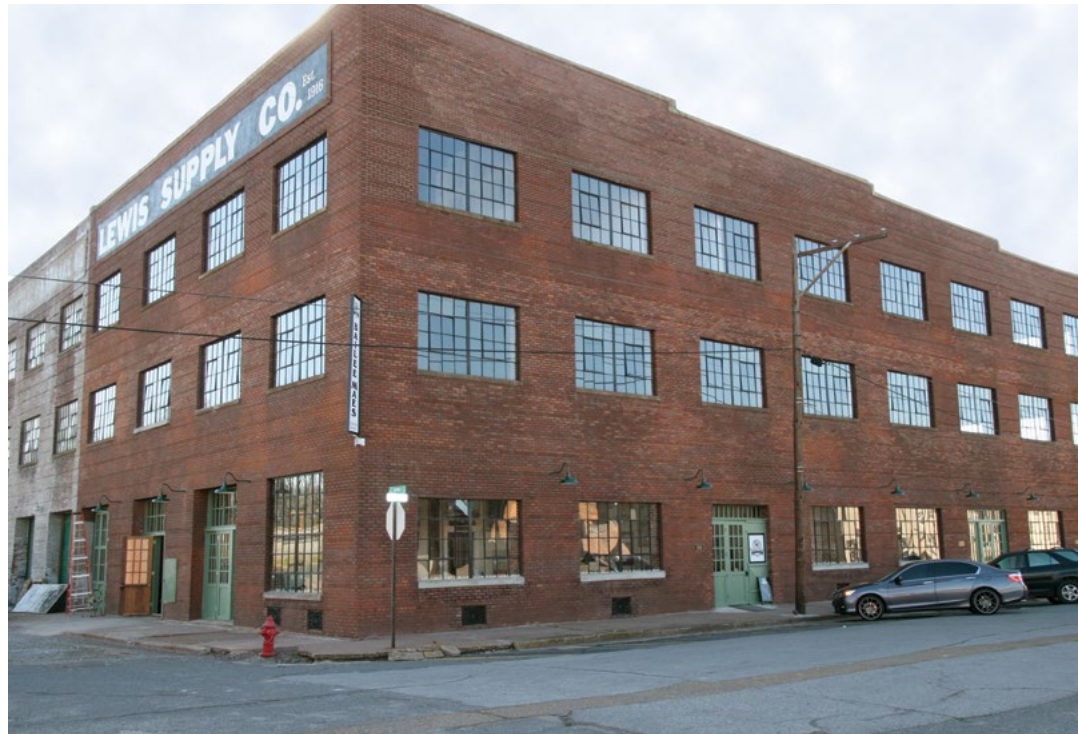
[20 a-d] The original steel windows in this industrial building were successfully repaired as part of the rehabilitation project (left).

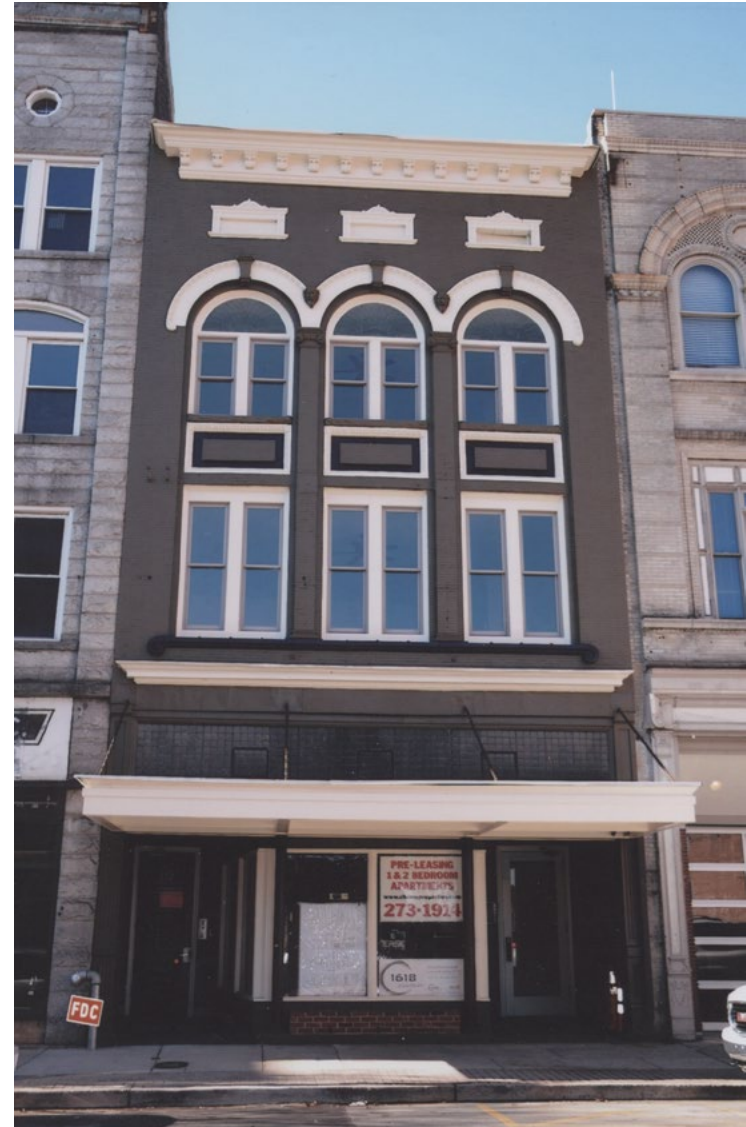
[22] **Not Recommended:** (a-b) The original wood windows in this late-19th-century building, which were highly decorative, could likely have been repaired and retained. (c) Instead, they were replaced with new windows that do not match the detailing of the historic windows and, therefore, do not meet the Standards (above).
