# Upland, CA

## Sidewalk and Curb Ramp Management Report

June 2024

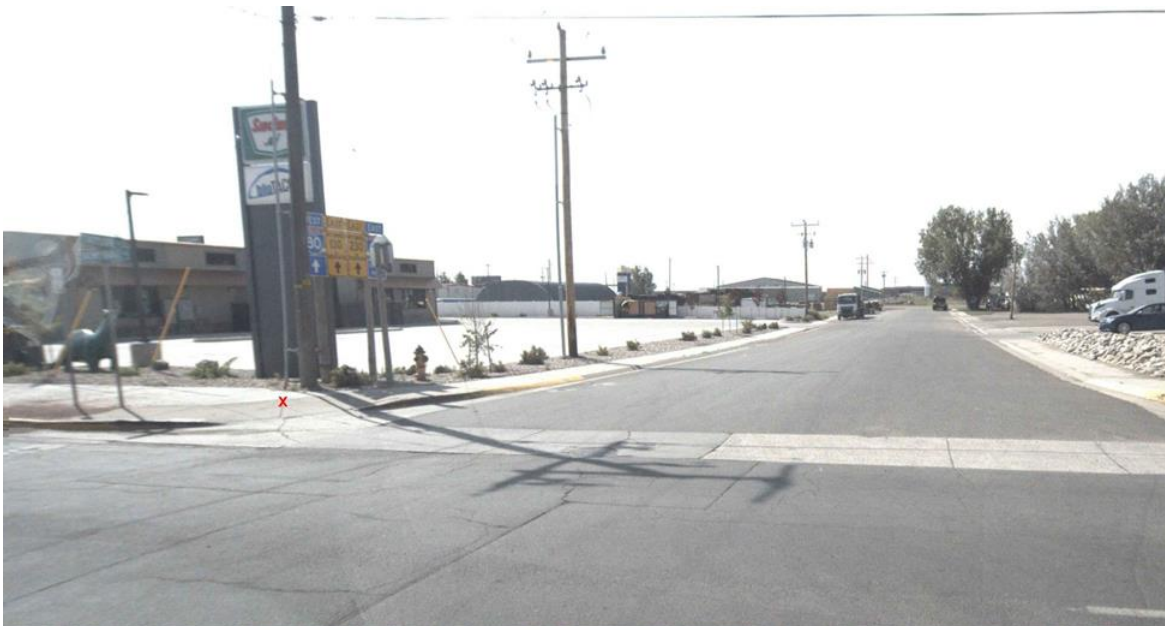
**Figure 14- ADA Conformity Level 4 Ramp**

**ADA Conformity Level 4 ramps (Figure 14)** have several ADA issues that need to be addressed, including slope issues, lack of landings, and/or missing/non-compliant facilities.

*No ADA Conformity Level 4 ramps were found in Upland. The above image is from another city and is provided here solely to give a comprehensive overview.*

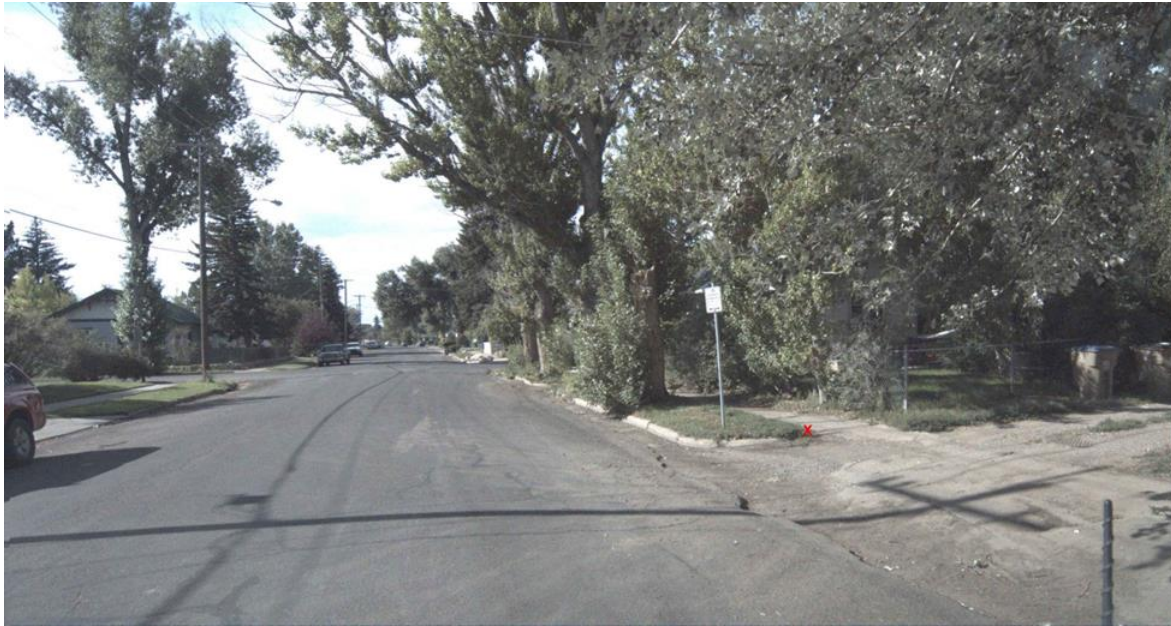
**Figure 15 - ADA Conformity Level 5 Ramp**

**ADA Conformity Level 5 ramps (Figure 15)** have several ADA issues and have many and/or excessive issues that need to be addressed, including slope issues, lack of landings, and/or missing/non-compliant facilities.

*No ADA Conformity Level 5 ramps were found in Upland. The above image is from another city and is provided here solely to give a comprehensive overview.*
